Damp Extracts From Survey

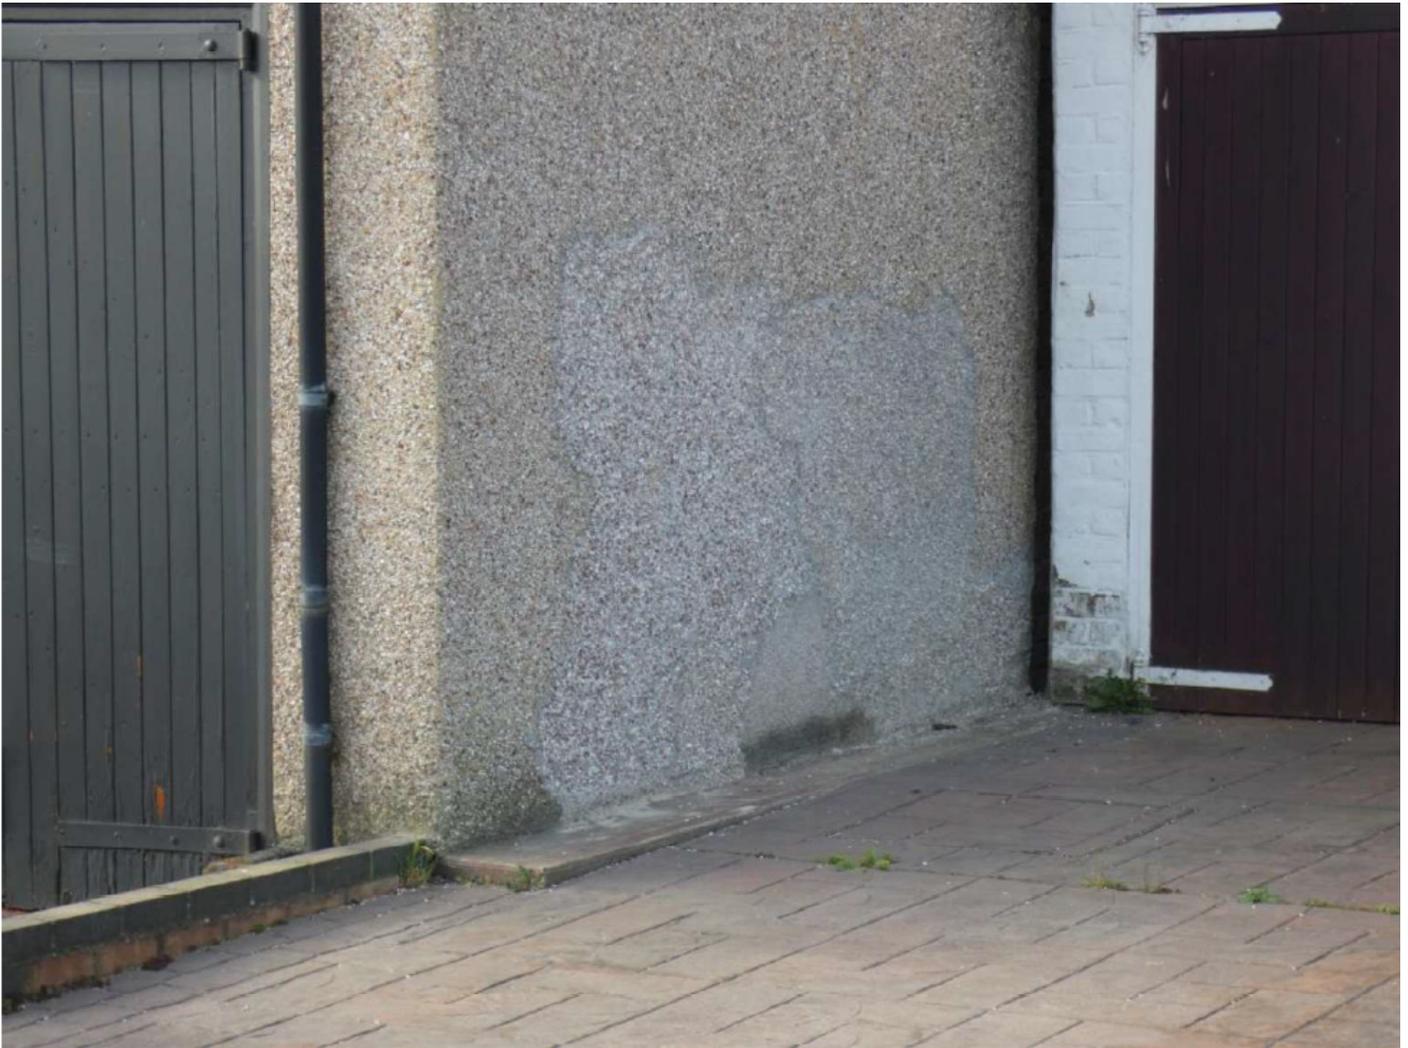
Rear extension - Prior to survey you mentioned that the forward face of this upstand wall was significantly damp stained but, I must report that at the time of this survey, the wall was well presented having evidently been repainted. The staining to which you alluded was almost certainly caused by rainwater running off the coping stones and dripping down onto the wall surface beneath. This small flat roofed area between the pitched roof and the older extension receives little natural daylight and so a persistently damp surface will have encouraged algae to grow. You might expect to have to carry out redecoration here on a more frequent basis than elsewhere.

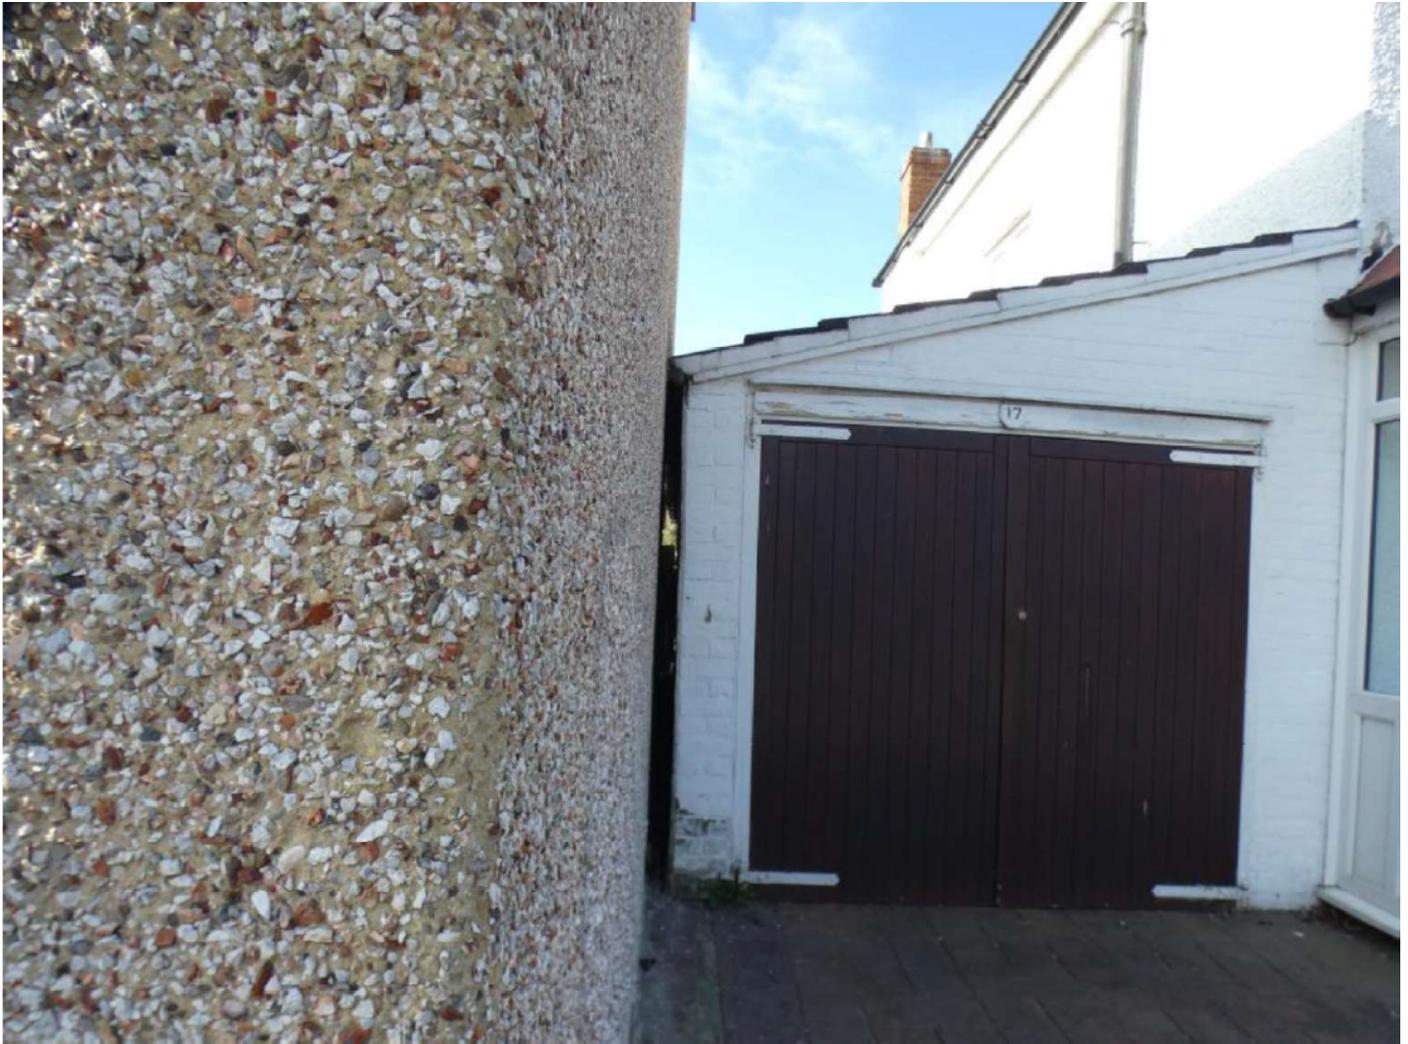
As will be described beneath under the section on the damp proof course, the ground levels around the perimeter of a house should be maintained at least 150mm beneath the perceived level of the damp proof course. In this case, as a result of the natural slope of the road, the right neighbour's concrete driveway is slightly higher than the surface of the floor in the garage at the subject property. This will inevitably cause water to enter the wall surface and in the long term this will cause the render to fail and fall away in patches as

has been the case here. Despite the recent patch repair the problem will continue and this will be returned to under several headings in the report.

There is a similar problem occurring because of rainwater sluicing off the neighbour's garage roof into a defective gutter which is allowing rainwater to sit against the wall at a higher level. There is causing penetrating dampness in the garage which will also be referred to under other headings. In the longer term you must expect more failure of the render and there is a long term liability for more extensive repairs or even complete re-rendering.

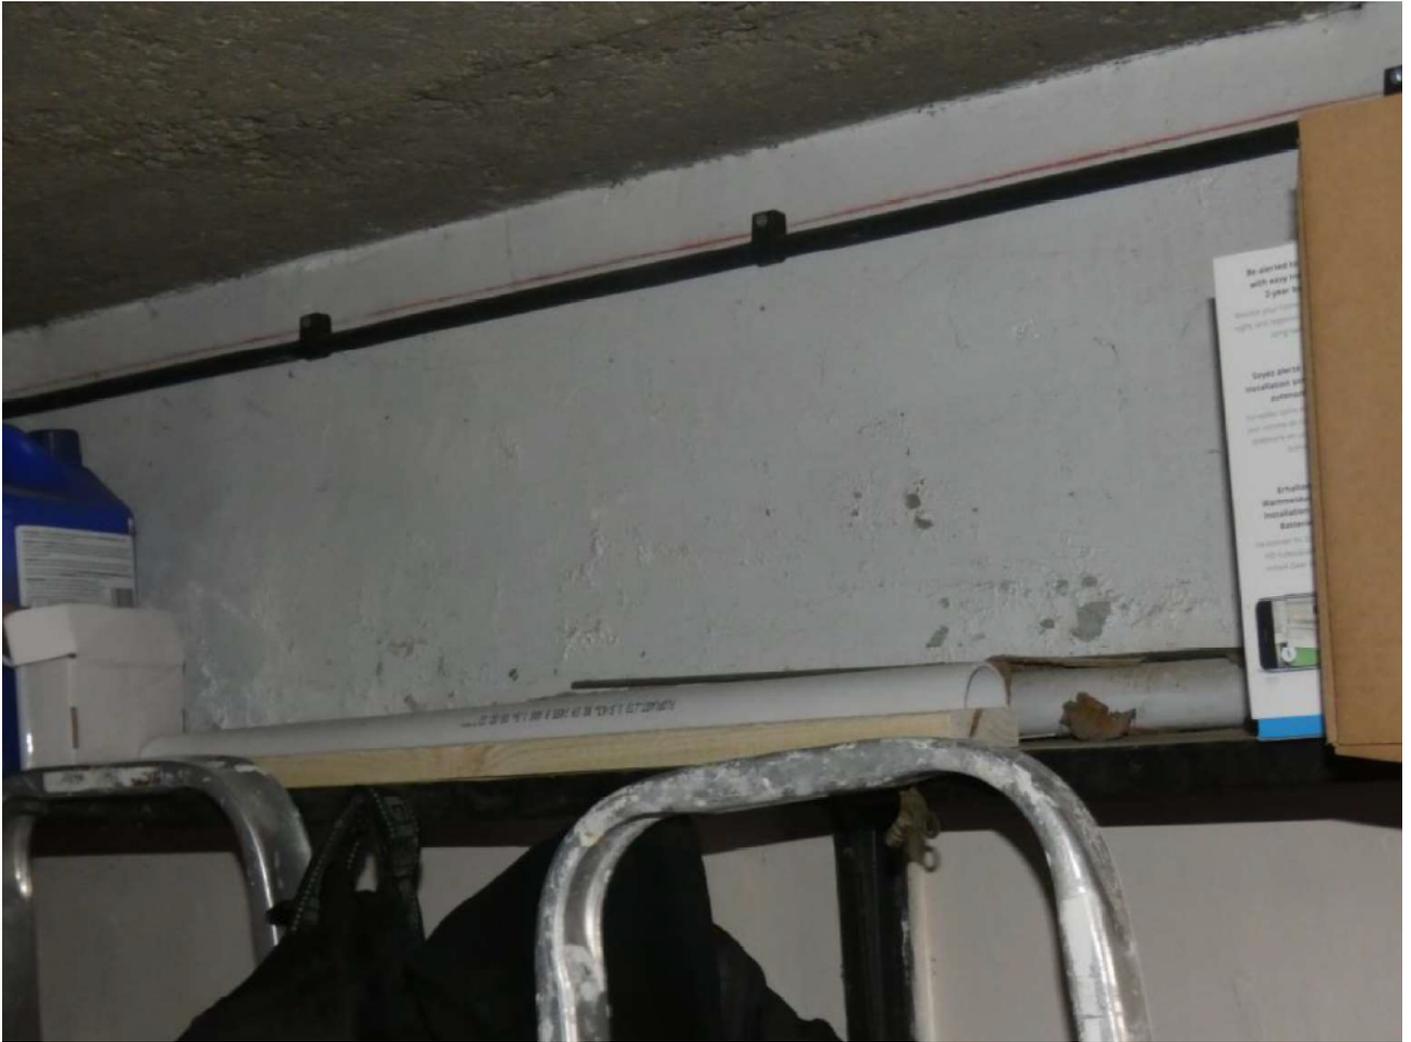
Although my opportunities to test the right hand wall of the garage were limited by the sheer amount of material being stored in this area, it was possible to reach through some of the storage and use a damp meter to test the moisture content of the right wall. As expected, this was well above normal limits despite looking quite smooth and tidy where it could be glimpsed. (It was my impression that the garage smelt of fresh emulsion paint at the time of this inspection and so it is possible that this area has been repainted). There are also some areas where the paint and plaster finishes were bubbling at a higher level which corresponded with the neighbouring house's garage roof and gutter.

The garage of this property is suffering from penetrating dampness because of the ineffective disposal of rainwater from overly high ground levels and a malfunctioning gutter detail between the neighbour's garage and the subject property.
